Cambridgeshire 'floating bus stops' interaction analysis

Final report

December 2015

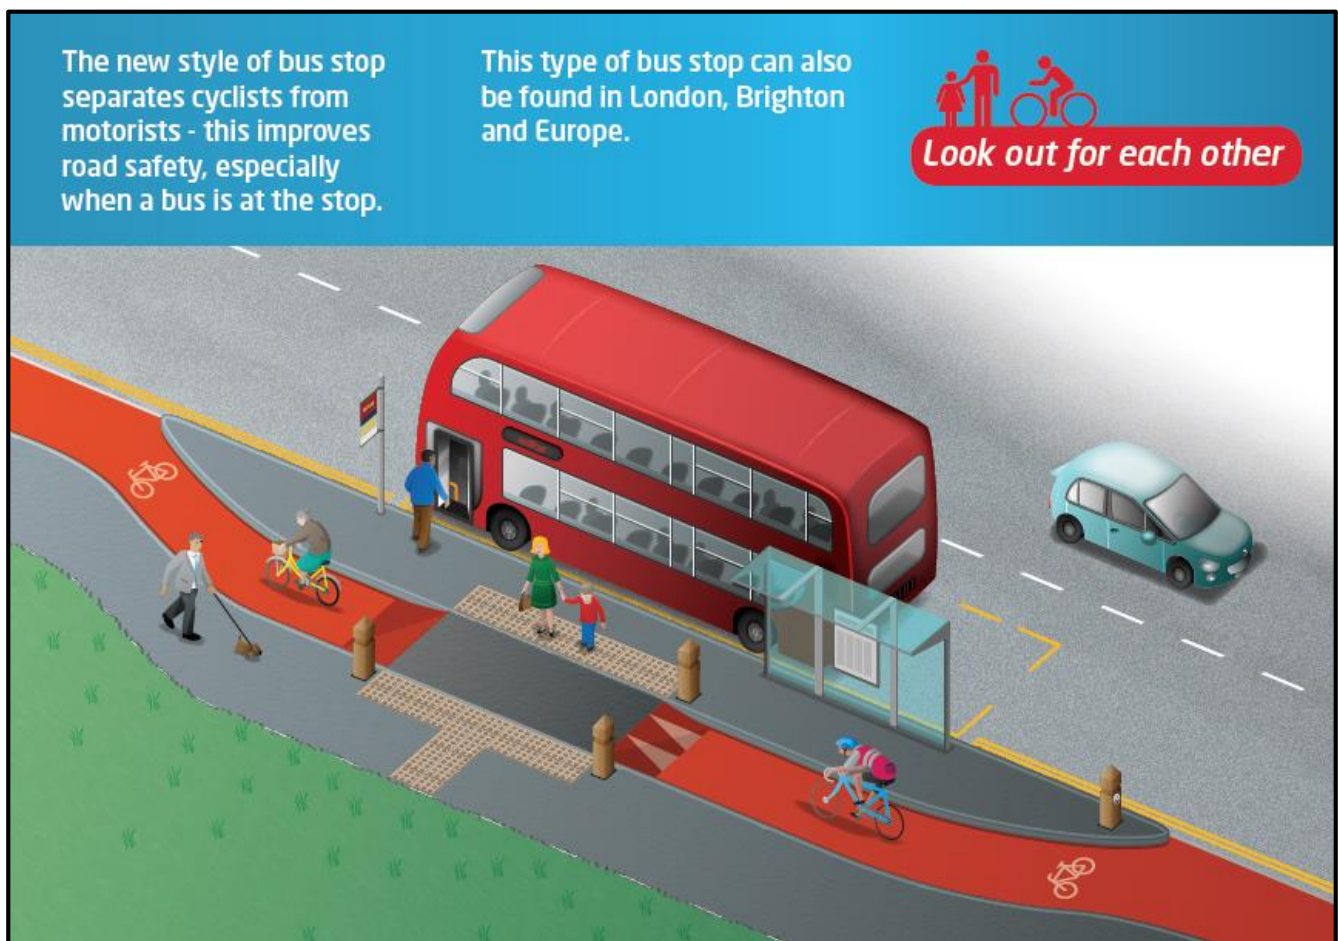
Image 1 Cambridgeshire 'floating bus stops' illustrations

Local stakeholders have raised some safety concerns related to these new designs. The key concern is that the design creates the potential for increased conflict between cyclists and pedestrians, and vice versa. The designs of these 'floating bus stops' are illustrated below in **Image 1**.

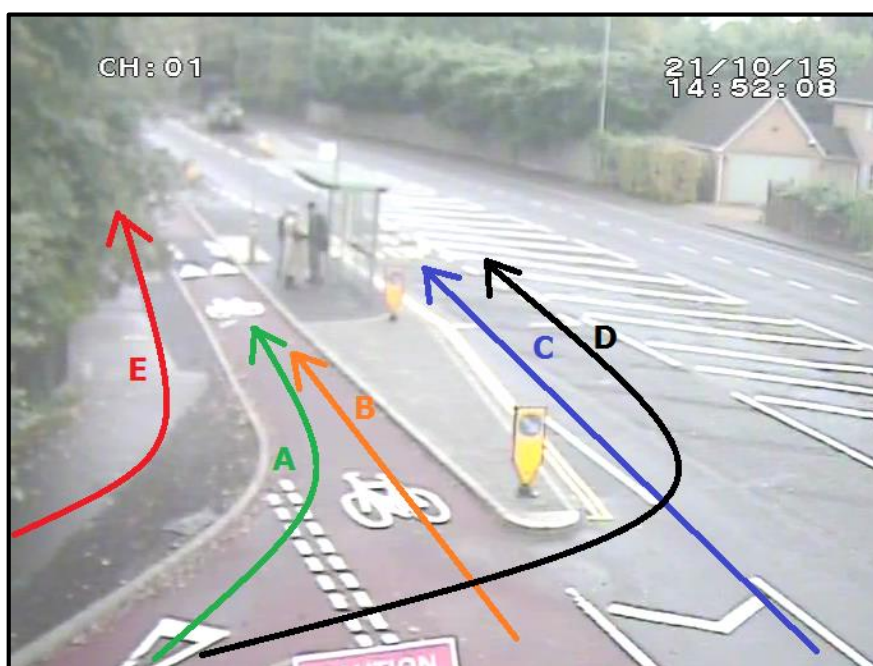
Image 2 Huntingdon Road movements

There were 5 movements the assessors observed and monitored at Huntingdon Road shown in **Image 2**. These movements were selected to address the aims of the interaction analysis.

A and **B** represented cyclists moving along the new cycle lane and the zone in which conflict with pedestrians crossing towards the bus stop or away from the bus stop to the pavement could occur. **C** and **D** looked at the interactions between cyclists and buses or cyclists and cars respectively.

In the process of video monitoring we noticed many cyclists performing movement **E** on the pavement. In consultation with CCC the decision was taken to monitor the number of cyclists who performed this movement and differentiate whether the cyclist performing this movement stayed on the pavement or moved on to the new cycle lane at the bus stop. Some foliage on the left hand side of the video obstructed the full view of the pavement, however we were able to reasonably determine what the cyclist did within the shot.

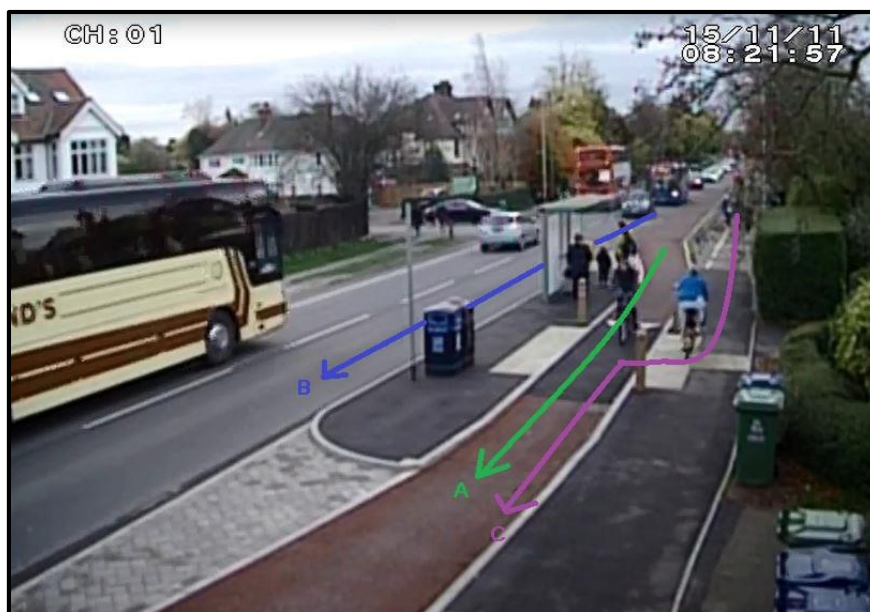
Image 3 Hills Road movements

For Hills Road there were 3 movements we were particularly interested in, these movements can be seen in **Image 3**. These movements were selected to address the aims of the interaction analysis taking into account the particularities of the bus stop design at this site compared to Huntingdon Road.

Movement **A** relates to cyclists moving along the new cycle lane and the zone in which conflict with pedestrians crossing towards the bus stop or away from the bus stop to the pavement could occur. Movement **B** looks at the interactions between cyclists and buses or cyclists and cars.

However, similar to Huntingdon Road (Movement **E**), we looked at movement **C** to ascertain if people came off the sidewalk at any point and on to the new cycle lane or whether they stayed on the pavement.

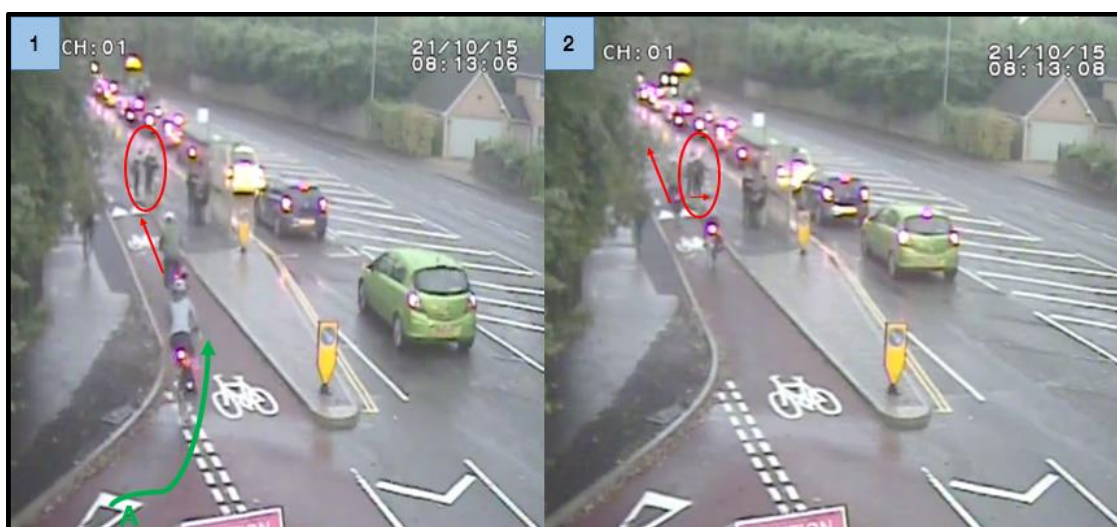
edge (Screenshot 2). The stepping forward was interpreted as being of a casual nature and the chance of collision was deemed minimal. Therefore incident 1 was scored as a 1 instead of a 2 despite the stepping aside movement. Also, it was difficult to attribute the movement solely on to the cyclist so we adopted a more conservative score. Scores 1 and 2 are still within the realms of normal behaviour and are considered generally safe.

Image 5 Screenshots of Incident 1: Cyclist interaction with pedestrian moving towards the bus stop at Huntingdon Road

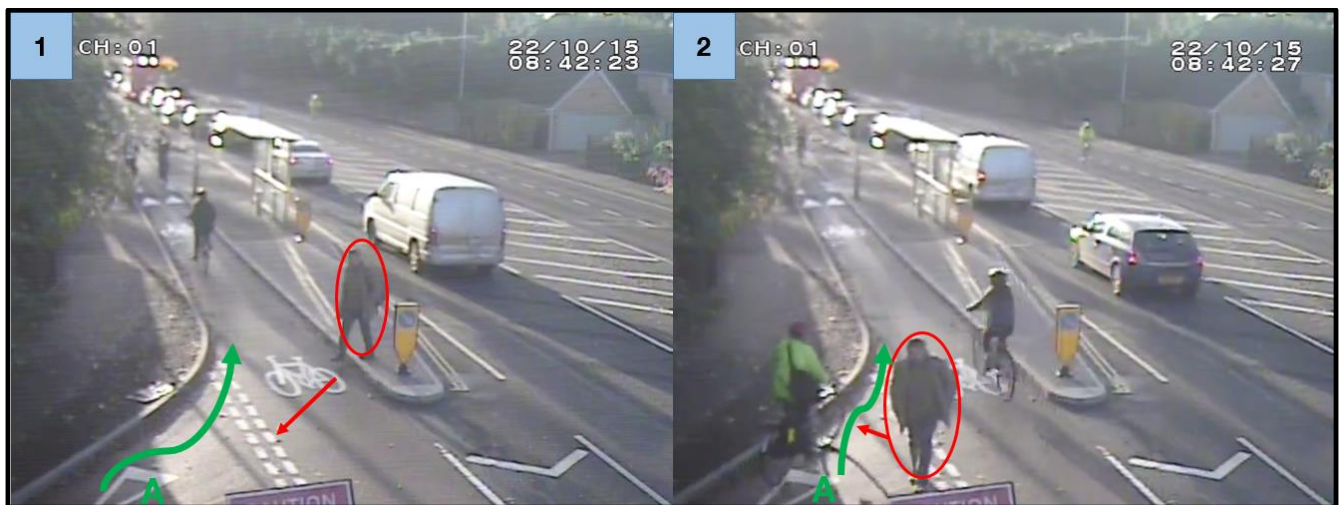
At Thursday peak morning a pedestrian (circled in red) moves from the 'floating bus stop' island across the cycle lane towards the cycle lane on movement **A** (Screenshot 1 **Image 6**). He does not use the official crossing allocated at the bus stop. A cyclist emerges on the side road making movement **A** and has to take precautionary action by moving and braking to ensure they do not collide with the pedestrian (Screenshot 2). We scored this incident with a score of 2 because the cyclist had to break and move to the left to avoid a collision but there was ample time to manoeuvre.

Image 6 Screenshots of Incident 1: Cyclist interaction with pedestrian moving away from the bus stop at Huntingdon Road

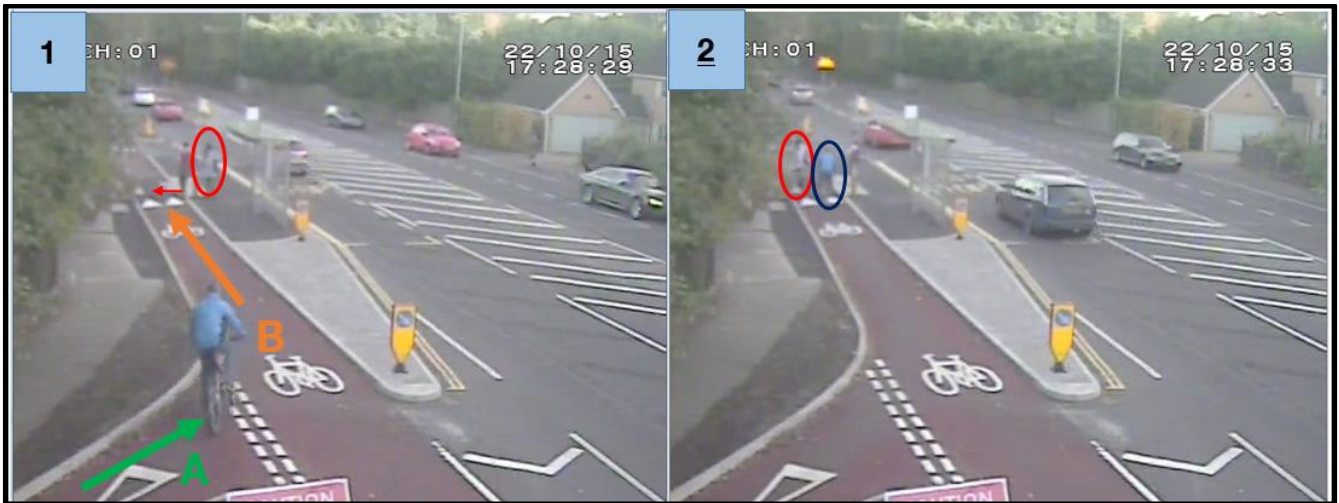
Image 7 shows two pedestrians talking at the 'floating bus stop' island with the back to the cyclist joining the cycle lane from movement **A** (Screenshot 1). One of the pedestrians (circled in red) started to cross the cycle lane moving away from the bus stop island without looking behind to see if a cyclist might be approaching. The cyclist possibly anticipated the movement from the pedestrian, slowed down and moved to the right avoiding the pedestrian (Screenshot 2). This incident was scored as 1 because the cyclist took precautionary actions with the risk of collision was minimal.

Image 7 Screenshots of Incident 2: Cyclist interaction with pedestrian moving away from the bus stop at Huntingdon Road

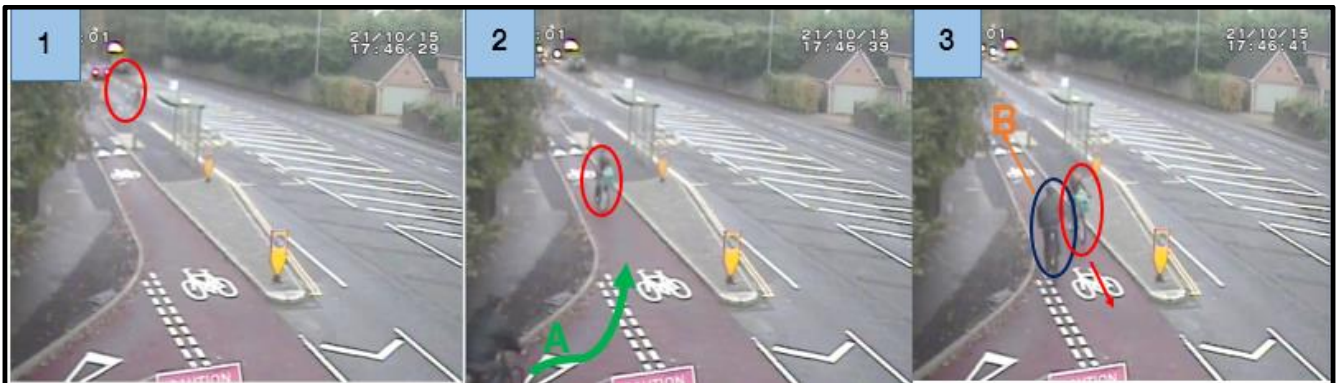
We observed a cyclist (circled in red) crossing the road from the opposite side of the road (Screenshot 1) and entering the cycle lane at the opposite end of the 'floating bus stop' (Screenshot 2). Subsequently there was an interaction with a cyclist coming from Movement **A** (at the left hand bottom corner in Screenshot 2) who was turning into Movement **B**. Evasive action was required by the cyclist on movement **A** not to collide with the cyclist using the cycle lane in Screenshot 3. This behaviour was scored as a 2.

Image 8 Screenshot of cyclist interacting with another cyclist

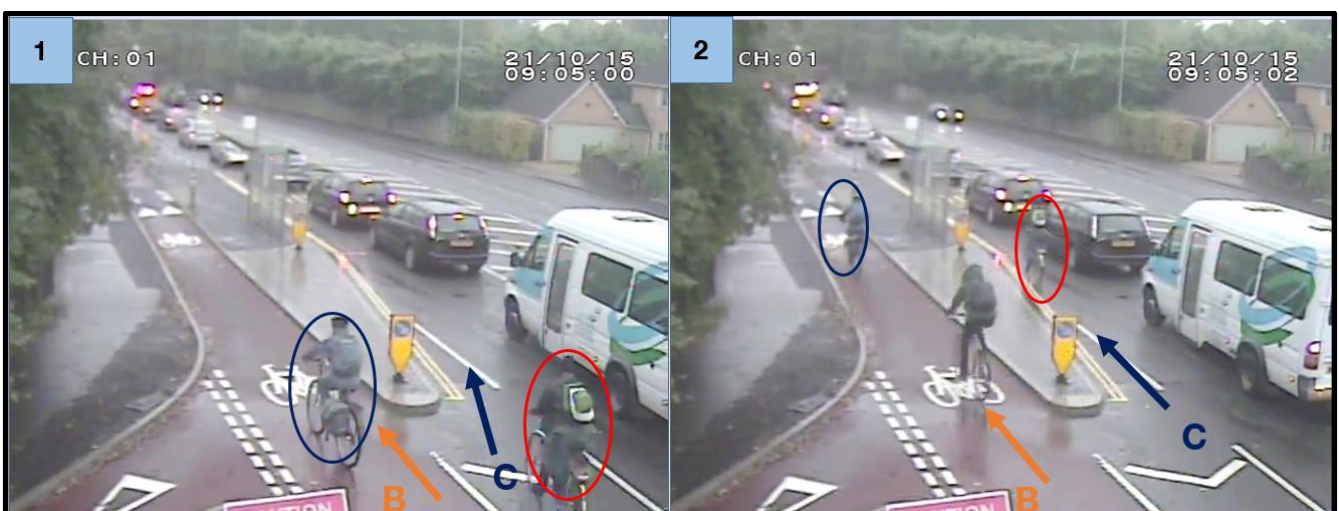
Image 9 shows a cyclist (circled in red) moving from the cycle lane in direction **B** on to the road doing movement **C** (Screenshot 1). Please take note of the cyclist circled in blue in front of the cyclist circled in red. Screenshot 2 shows the cyclist on movement **C** passing on the left of the cars queuing on Huntingdon Road. It gave the impression that the cyclist was trying to overtake the cyclist in the cycle lane (circled in blue) by moving onto the road.

Image 9 Screenshot of cyclist moving from B to C

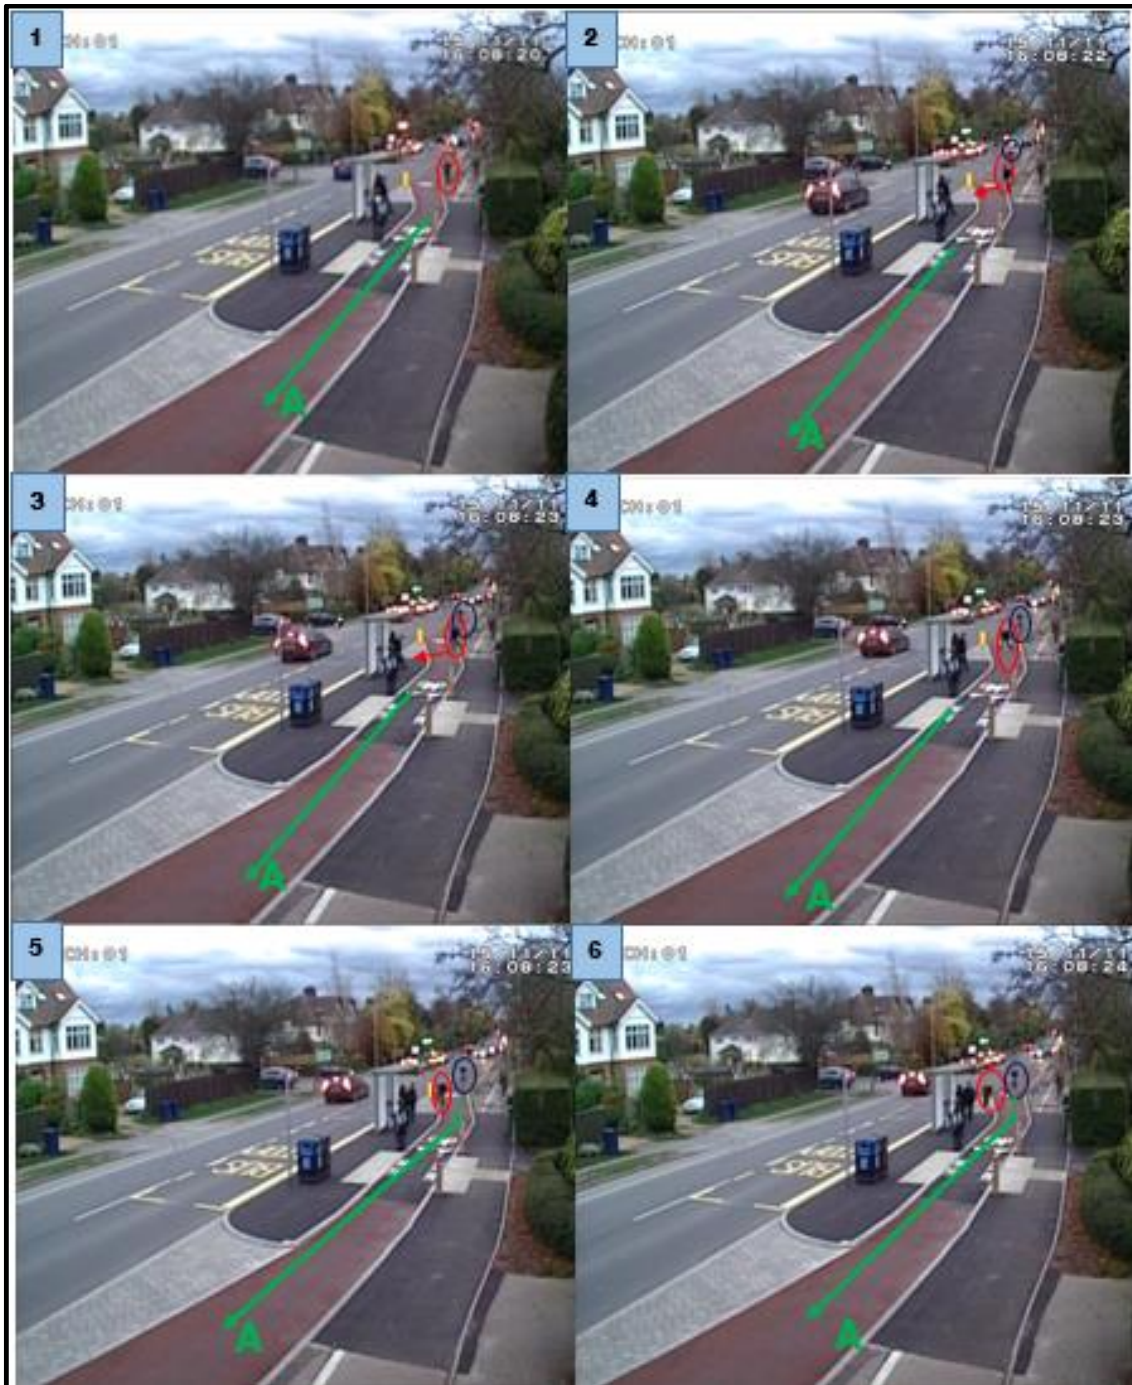
A cyclist was approaching from movement **A** at a pace deemed 'normal' (Screenshot 2 in the blue circle). The pedestrian looked right (Screenshot 2) and appeared to see the approaching cyclist but still decided to cross the cycle lane. The pedestrian then runs across the cycle lane seemingly to avoid any collision with the cyclist (Screen shots 3 and 4). The cyclist appears to react to the pedestrian by altering their cycling route slightly, swerving slightly to the left to change their path and to avoid the pedestrian (see Screenshots 5 and 6). The interaction was scored as a 2 due to the sudden movement seen by the pedestrian and precautionary measures adopted by the cyclist. Scores of 2 are still within the realms of normal behaviour and are considered generally safe.

Image 11 Screenshots of Incident 1: Cyclist with pedestrian moving towards the bus stop at Hills Road

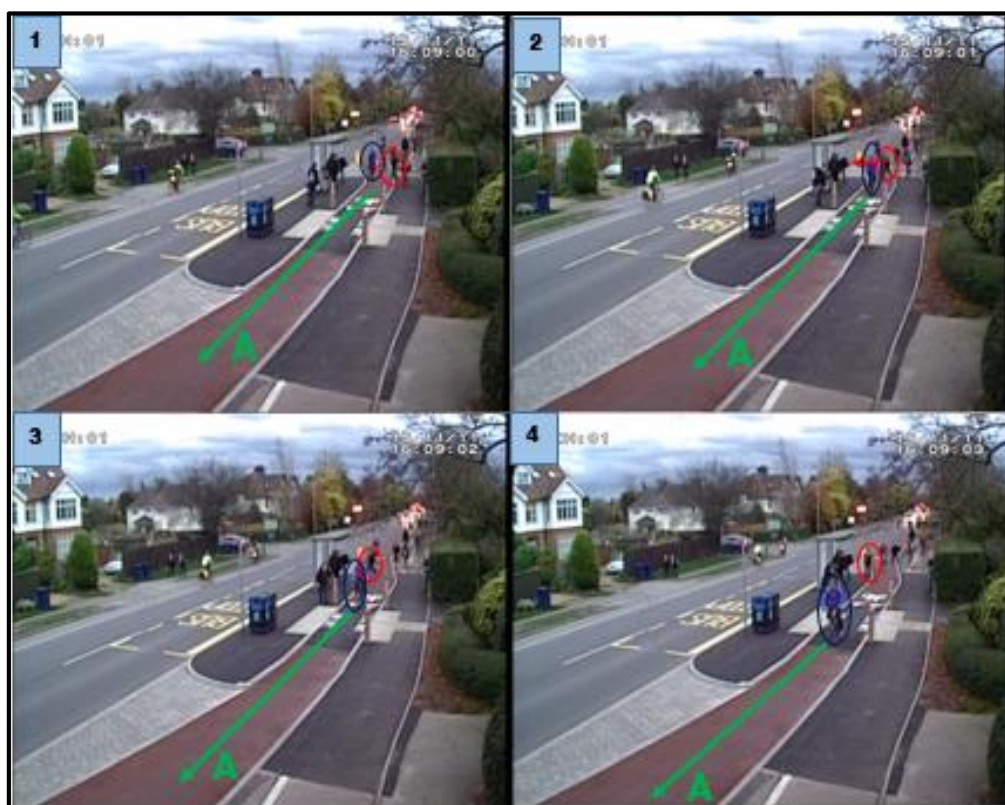
A cyclist approached from movement **A** at a normal pace seen along the cycle lane and can be seen in the blue circle in Screenshot 1. The pedestrian (red circle Screenshot 1) looked right and sees the approaching cyclist so waits for the cyclist to pass before crossing the cycle lane (Screenshot 2). The pedestrian waited as a precautionary measure, with minimal chance of collision with the cyclist (Screenshots 3 and 4). The cyclist does not appear to slow down or change direction but continues on the cycle lane at the same speed. The interaction was scored as a 1 due to there being no sudden or quick reaction needed by the road users, but an anticipatory waiting behaviour shown by the pedestrian with lots of time to do so. This behaviour is deemed normal road-using behaviour. This behaviour was seen on many occasions during this time period, with a steady flow of cyclists and lots of pedestrians around the bus stop.

Image 12 Screenshots of incident 2: Cyclist interaction with pedestrian moving towards the bus stop at Hills Road

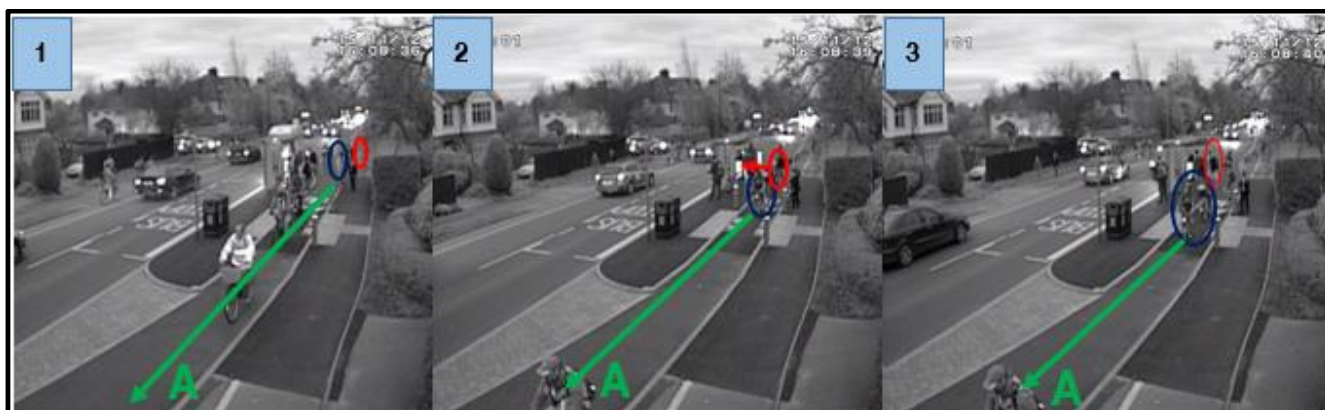
Many young people were crossing the cycle lane to the bus stop and walking around the area during this period. In this incident, a pedestrian (one of these young people Screenshot 1 red circle **Image**

13) appears to stop and wait for a number of cyclists (blue circle Screenshot1) to perform movement A before crossing the cycle lane (Screenshot 2 red circle). The pedestrian took a precautionary action with very minimal chance of collision with the approaching cyclists. This time of day is busy with both cyclists and pedestrians and it appears the pedestrian chooses a safe time to cross in between cyclists who are approaching at a steady flow (Screenshot 3). The behaviour is deemed normal road user behaviour, with an anticipatory action taken by the pedestrian, so was scored a 1.

Image 13 : Screenshots of incident 3: Cyclist with pedestrian moving towards the bus stop at Hills Road

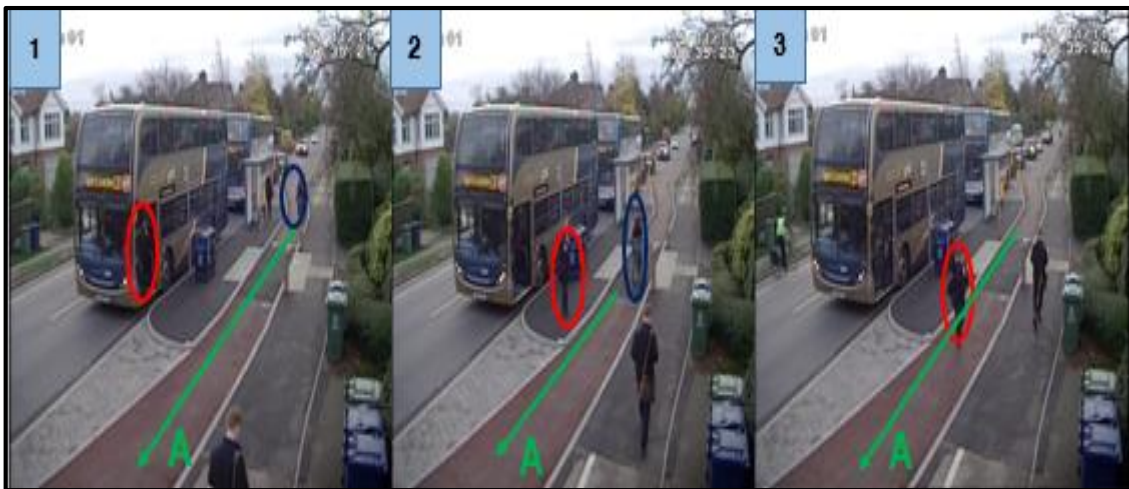
At peak time on Wednesday morning a pedestrian exits the bus which was in the bus stop and enters the ‘floating bus stop’ island (see **Image 14** Screenshot 1 red circle). A cyclist approached from Movement **A** (See screenshot 1 blue circle) causing the pedestrian to wait for the cyclist to pass before continuing to cross the cycle lane. The pedestrian took a precautionary action with very minimal chance of collision (Screenshots 2 and 3). The behaviour is deemed normal road user behaviour, with an anticipatory action taken by the pedestrian, so was scored a 1.

Image 14 Screenshots of Incident 1: Cyclist interaction with pedestrian moving away from bus stop at Hills Road

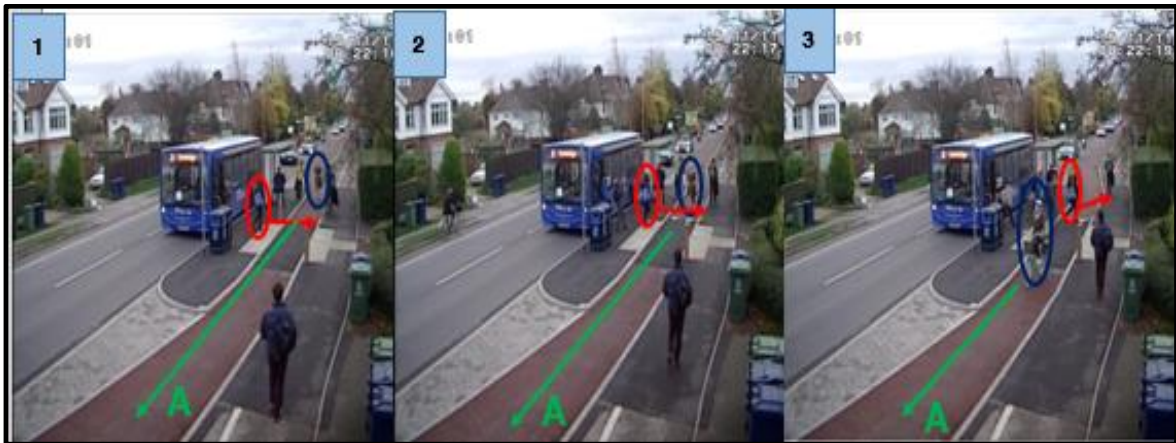
At peak time on Wednesday morning a pedestrian exited the bus which had stopped in the bus stop and walked in to the ‘floating bus stop’ island (see **Image 15**). The pedestrian (red circle Screenshot 1) appeared to walk directly in the direction of the pavement adjacent to the cycle lane. As the pedestrian approached the cycle lane, a cyclist was coming along Movement **A** (Screenshots 1 and 2), causing the pedestrian to wait for the cyclist to pass before continuing to cross the cycle lane. The pedestrian took a precautionary action with very minimal chance of collision. The behaviour is deemed

normal road user behaviour, with an anticipatory action taken by the pedestrian, for this reason the interaction was scored a 1.

Image 15 Screenshots of Incident 2: Cyclist interaction with pedestrian moving away from bus stop at Hills Road

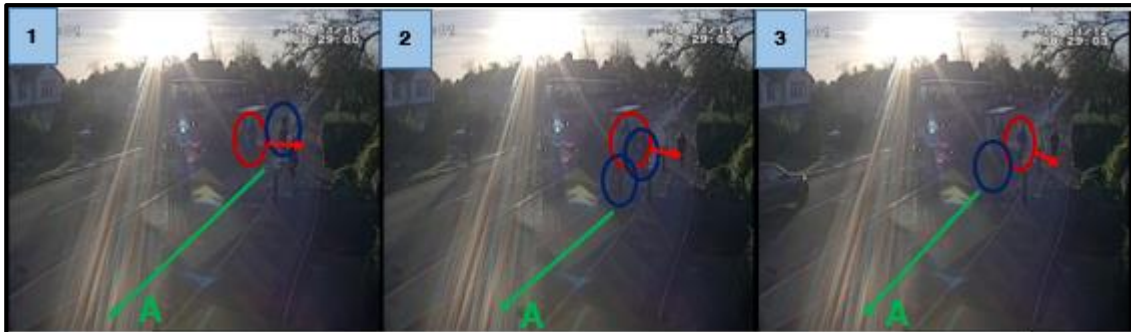
At peak time on Thursday morning a pedestrian exited the bus which stopped at the bus stop. A number of pedestrians left the bus at the same time (see **Image 16** red circle Screenshot 1). As the pedestrian approached the cycle lane, two cyclists were performing Movement **A**. The pedestrian appears to walk along the bus stop and stop to allow the cyclists to pass in order to cross the cycle lane and reach the adjacent pavement (Screenshot 2). The pedestrian takes a precautionary action with very minimal chance of collision. The behaviour is deemed normal road user behaviour, with an anticipatory action taken by the pedestrian to wait and cross when safe. As a result the interaction was scored as a 1.

Image 16 Screenshots of Incident 3: Cyclist interaction with pedestrian moving away from bus stop at Hills Road

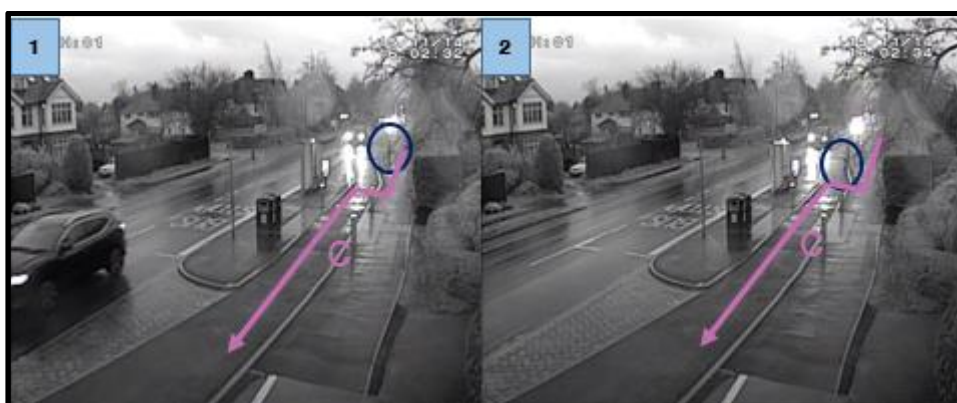
It was observed that many cyclists use the pavement to the right of the bus stop in both directions, and were found to weave in and out of pedestrians. Some cyclists used the pavement and then joined the cycle lane on Movement C which is shown below in (Image 17).

Image 17 Screenshots of cyclists making movement C

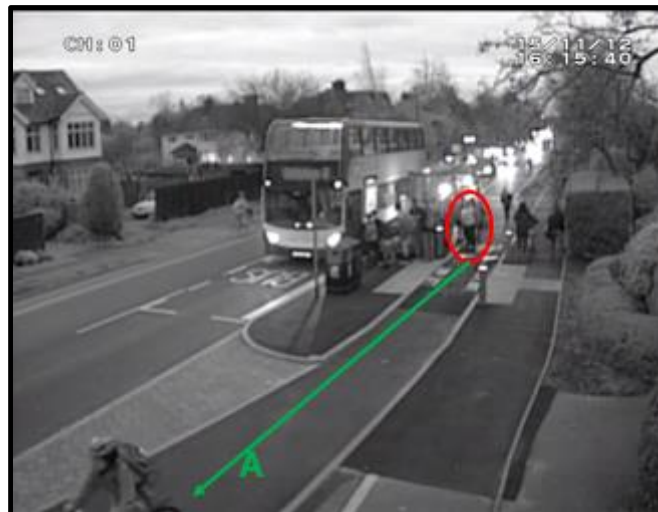
It was observed that during weekday afternoon peak times, there tended to be a lot of young people after school waiting in the area in and around the bus stop. The young people appeared to be waiting for a bus after school, and tended to congregate at the 'floating bus stop' and from there into the cycle lane. The young people were observed using the cycle lane as an extension of the bus stop when the bus stop was overly congested. In **Image 18** young people circled in red stood in the cycle lane when the stop becomes crowded. This was exacerbated by the bus being at the stop. The screenshot shows an incident that took place at Thursday peak-pm and shows the young people using the cycle lane as an extension of the bus stop. This particular incident did not cause any conflictual interactions with other road users but has the potential to cause conflict in the future with cyclists on Movement **A**.

Image 18 Screenshots of after school crowding at the bus stop

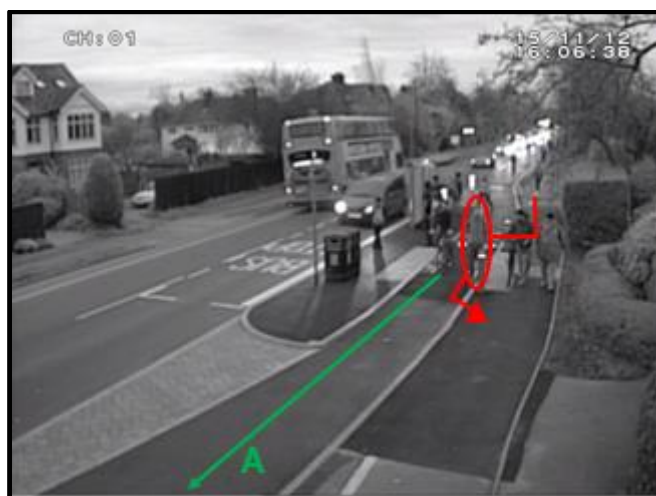
It was also observed on a few occasions that large numbers of young people walked along the pavement in a group and used the cycle lane as an extension of the pavement. It was seen that some young people used the cycle lane for the entire duration of their journey whilst others used it temporarily and re-joined the pavement at different sections of the cycle lane. **Image 19** provides an example of this behaviour. The incident took place at Thursday peak afternoon and shows a pedestrian (circled in red) on the cycle lane, using it as an extension of the pavement. Two of the pedestrians can be seen walking along with their bikes, while two are walking alongside before re-joining the pavement further along to the right. They did not appear to be paying heed to cyclists or the function of the cycle lane. In this instance there were no conflictual interactions between road users and so was not included in the interaction score.

Image 19 Screenshots of large groups using the cycle lane as an extension of the pavement

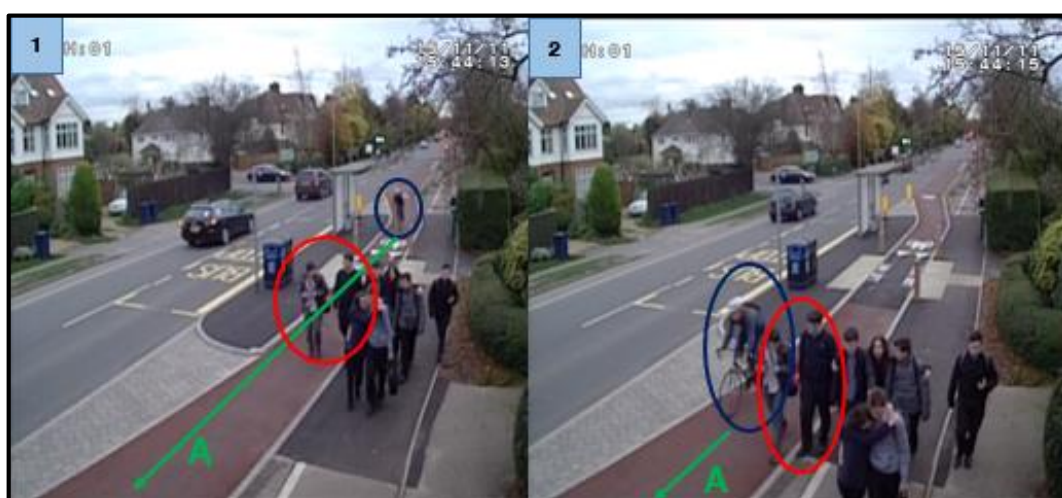
It was also observed that young people often used the cycle lane for the duration of their journey. The incident in **Image 20** took place on Wednesday peak afternoon and shows pedestrians on the cycle lane, using it as an extension of the pavement for their journey (see Screenshot 1). The pedestrians caused the cyclist to anticipatory brake and swerve to reduce the chance of collision but with ample time to manoeuvre. If this type of interaction were included in the interaction analysis, it would have been scored a 1, as the cyclist took precautionary action with minimal chance of collision. This type of interaction was not scored in the report, as the pedestrians did not attempt to cross the cycle lane at any time or attempt to use the 'floating bus stop'.

Image 20 Screenshots of large groups using the cycle lane as an extension of the pavement
