Report of two site surveys carried out 26th and 27th September 2011.

Main themes which recur are:

- A) Permeability of site including signage and safety
- B) Cycle parking lack of and poor design of some of
- C) New development versus existing infrastructure

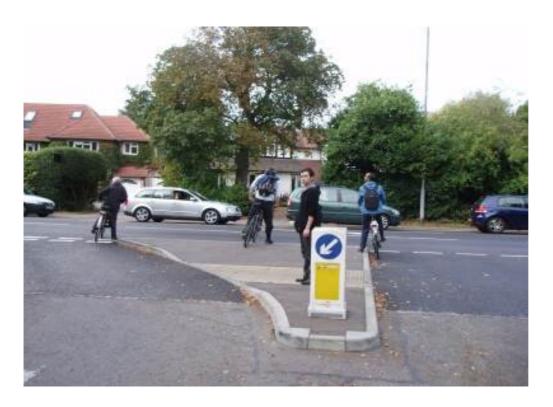
1.1) Exit of Adrian Way to Long Road.

Surveyed at circa 5pm. Large number of cyclists turning right in contravention of ban on right turns onto Long Road. This is clearly a popular route for cyclists to enter and exit the site from Hills Road and the City Centre, although there are no hard data on this (see 5.3). Anecdotal reports suggest many cyclists find this a much safer route than using the route across Car Park H and the main driveway.

Solution: A clear solution immediately presents itself, namely modification of the central island to accommodate right turning cyclists and altering the "no right turn signs" to "except cyclists".

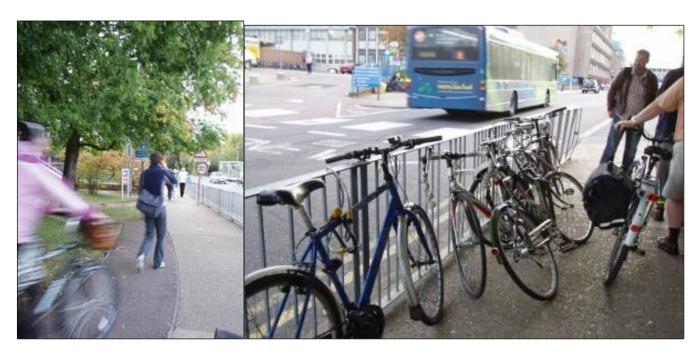
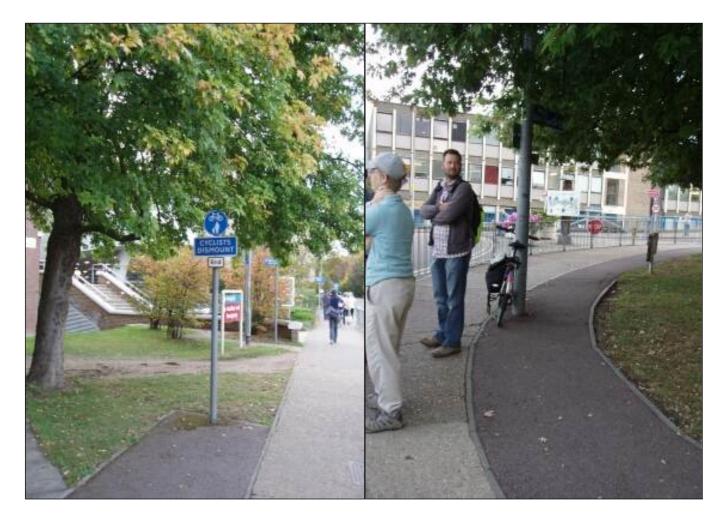
1.2) Flagpole roundabout to A+E and Main Entrance.

The shared use path in reverse of the One-Way system is narrow (only 1.25m wide), and crowded with pedestrians and parked bikes. It ends abruptly, forcing all cyclists to head towards the City Centre even if they wish to head for the Babraham Road. Even the route to the City Centre is discontinuous, with a totally ignored "cyclists dismount" sign between the corner and the crossing to car park H. The presence of the railings which are dangerous at least give a little more cycle parking! These railings give an impression that pedestrians are to be herded as far as possible out of the way of the traffic, rather than giving priority to pedestrians over the traffic. There is a large detour to walk to the bus station.

We note that the main drive, owing to many vehicle movements, is hostile to cyclists. The contraflow path alongside the LMB and Clinical School is too narrow, ill defined and used by pedestrians to be fit for purpose.

Solution: Solving the multiple issues, many safety-related, in this area will require further survey work and a detailed study.

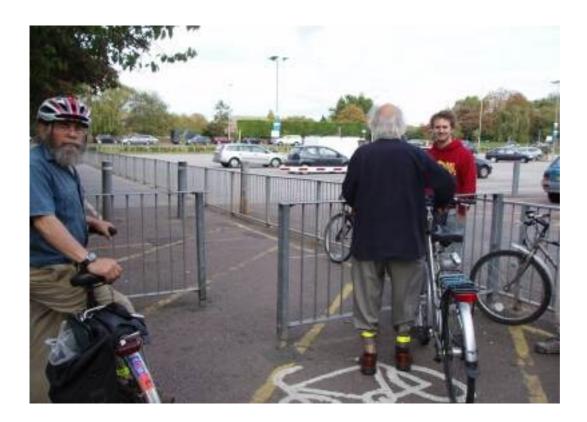
1.3) Route across car park H.

Barriers, access and means to cross road to access main hospital, combined with car park entrance very nearby are confusing and could be improved. We have general safety concerns about the road crossing combined with confusing car park entrances.

Solution: : Solving the multiple issues, many safety-related, in this area will require further survey work and a detailed study.

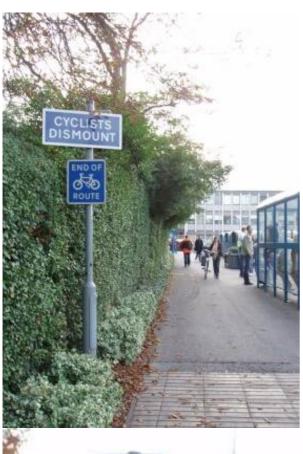
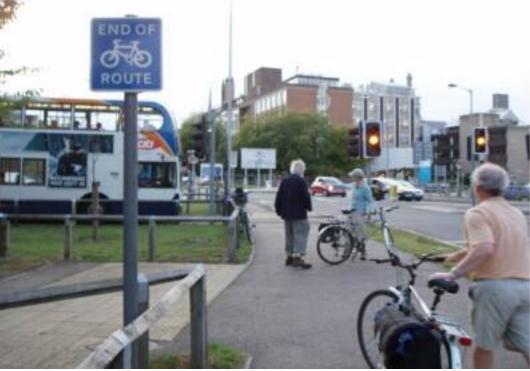
1.4) Route to Babraham Road from Outpatients/A+E.

While doing this survey, we ran into a colleague of HC who lives on Hinton Way, Great Shelford (SN). There is an incomplete route behind the bus station (signage indicates that "route ends" halfway along that path). The alternative route on the shared use path around the main roundabout is inadequately signed as "shared use" and there are no indicators on any of the sets of traffic lights, especially the bus exit from the bus station that it is safe for either pedestrians or cyclists to cross. Access to either route is opaque, especially as the many railings make it impossible to make a possibly sensible decision for many to rejoin the main carriageway. SN, when interviewed by HC confirmed that she finds this area the most difficult and dangerous part of her commute.

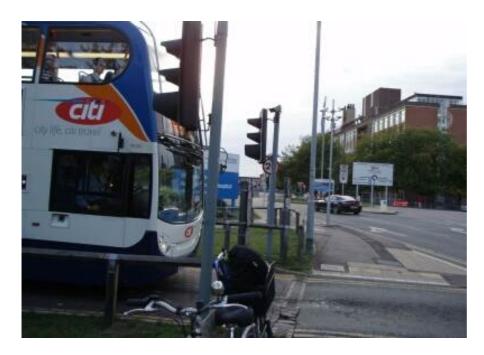
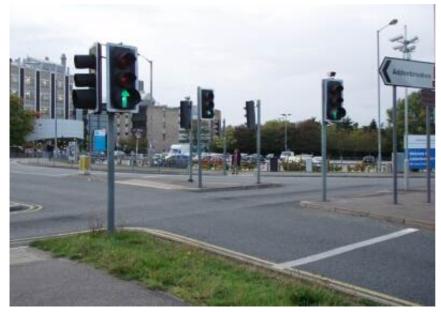
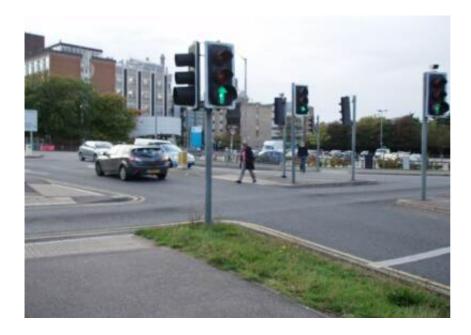
1.5) The main roundabout.

As mentioned in 1.4 above, the infrastructure of this roundabout is totally hostile to pedestrians who wish to cross any of the roads or to cyclists using any of the shared use paths which apparently exist around at least part of the roundabout (eg linking shared use path on Babraham Road with shared use path on Hills Road). As each set of lights only controls a traffic lane flowing in one direction, there is no excuse for not having an equivalent "green man" indicator on each light post to indicate to pedestrians when the lights are red for motor vehicles and will be so for long enough for it to be safe to cross that sector. This will lead to no extra increase in traffic congestion as the light phases will not need to be altered at all, only retrofitting

of the appropriate "green man" lights for each leg of the roundabout to indicate when there is a safe red light for vehicles on the main carriageway. Currently, pedestrians are having to guess when it might be safe to cross, especially at the bus exit to the bus station.

Solution: A clear solution immediately presents itself as outlined above, namely the fitting of "green/red men" lights on all relevant posts to indicate to pedestrians when it is safe to cross. These need not necessarily be button operated if there is a regular switching cycle to all lights at all times of day, otherwise, they will need "request" buttons as per Puffin crossings.

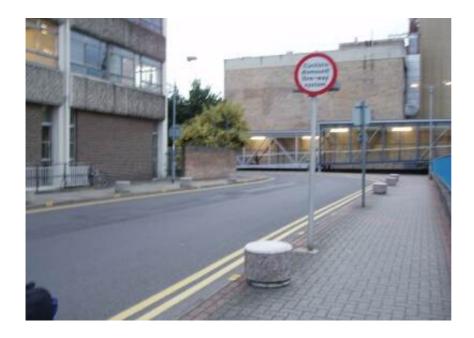
1.6) No "legal" or even vaguely convenient route from Adrian Way to Main Hospital entrance.

This is a serious permeability issue, which, if solved, could be used to provide a safer route to access the main entrance than the main drive.

Solution: If the blind corner around the Clinical School, as seen in the photograph can be "smoothed out" or visibility improved by use of mirrors, we so no reason that a contraflow cycle lane cannot be inserted in the same way that one exists on Keith Day Road, along with appropriate signage and speed calming measures for oncoming motorised traffic.

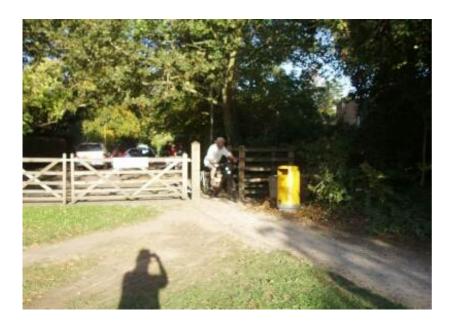
1.7) Entrance onto site at Red Cross Lane.

Approx 10 minutes spent at survey site suggested wide usage by pedestrians and cyclists. However, there is a narrow gate that a cycle or wheelchair cannot be got through, and a wider gap that they can, but which has no flush or even dropped kerb.

Solution: This entrance and associated infrastructure need thorough modification in order to regularise cycle access and improve conditions for pedestrians, especially the disabled.

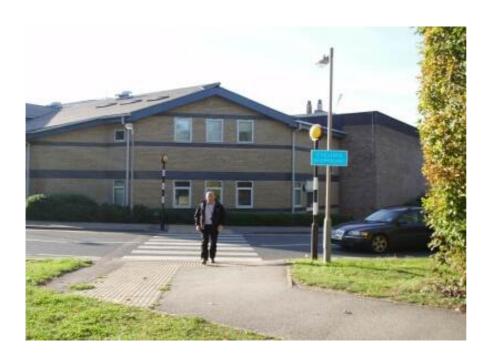
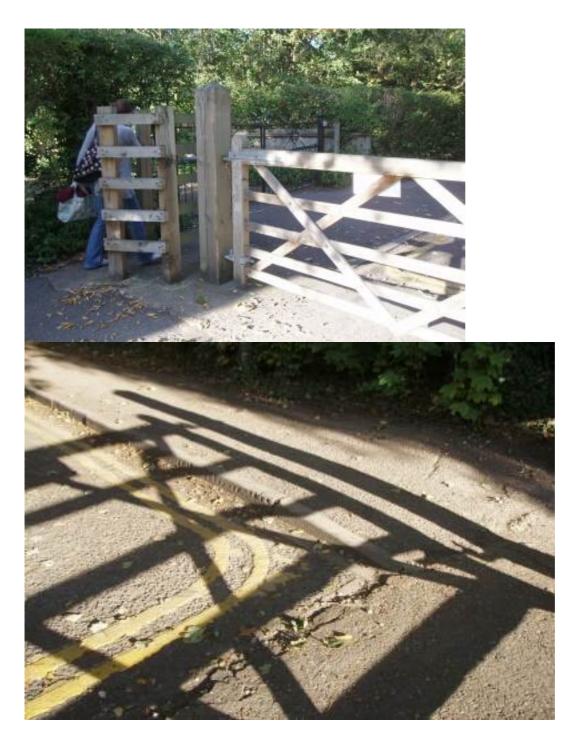
The access then peters out, with a "cyclists dismount" sign in the direction that many cyclists may wish to proceed in. There is potential pedestrian/cyclist conflict owing to pinch points and general lack of design. There is plenty of space for one of the many sensible solutions mooted while we stood there. For those travelling either from the Babraham Road Park and Ride, from the eastern end of Great Shelford or from the estate on the southern side of Queen Edith's Way, this could be a sensible safe alternative to the route in 1.4, especially if working on the western or southern side of the campus, but currently is not fit for purpose.

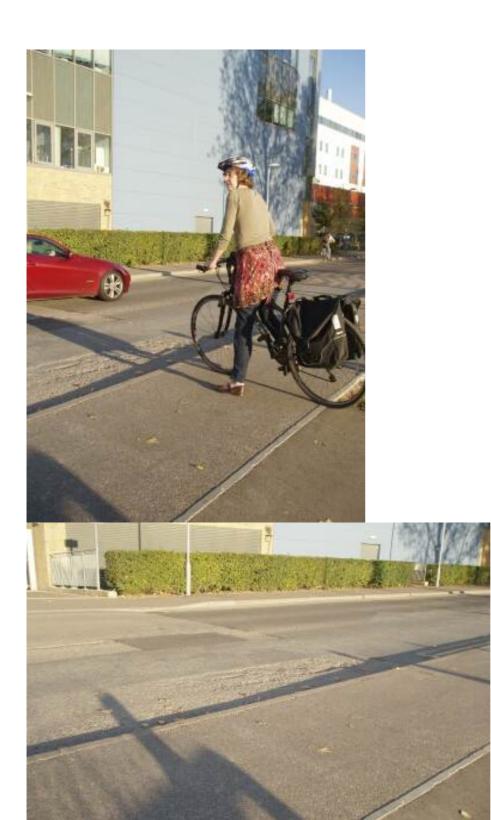
1.8) Entrance onto path across fields onto Busway.

Although we accept this is a temporary arrangement, it is not clear as to the time span of the final route onto the Campus. As it is used by many cycle commuters from Trumpington, the lack of a proper flush kerb, or even a dropped kerb is a serious impediment to easy or safe access.

Solution: Short term modifications to generate flush kerbs and signage on the roadway to indicate that a cycle route is joining/crossing the road.

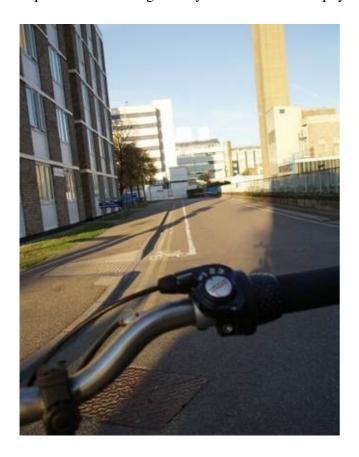
1.9) Frank Lee Centre to Granchester House area.

Incomplete cycle contraflow lane in front of S block means that access to Treatment Centre from Hills Road, via shortest route, is interrupted. Signage where contraflow starts is poor. End of route at junction with Adrian Way is poorly designed, with build out to prevent cyclists from just following a sensible route and instead having to do a confusing hop onto the pavement for a few yards then give way to other traffic

on the link road. Can guided buses do the corners on this road without impinging on the cycle route? If not, this is a serious safety issue. Cyclists should not, while legally cycling along a dedicated lane, be expected to have to give way to traffic which is physically unable to keep to its correct lane.

Solution: : Properly solving the multiple issues, many safety-related, in this area will require further survey work and a detailed study.

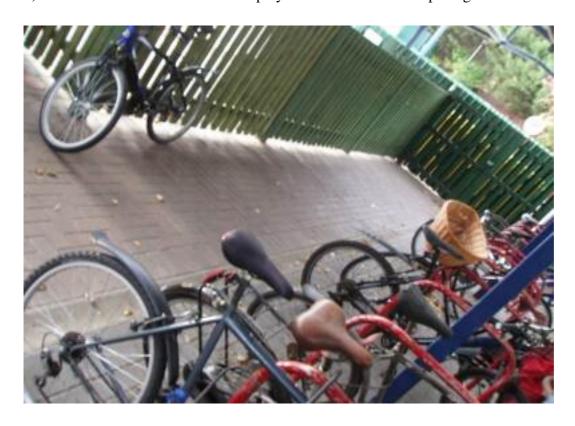
a) Rear of Blood Transfusion. Employee card access shed. Spacing of racks a little narrow (70cm).

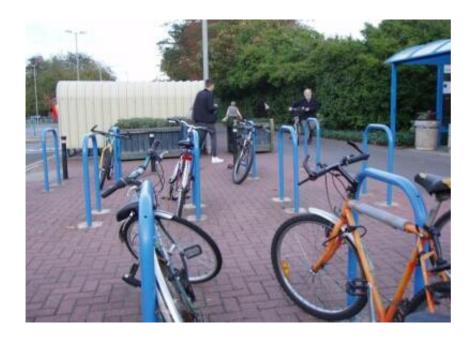
b) By Bus Station. Good placing of sheffield stands (1.13m). Uncovered.

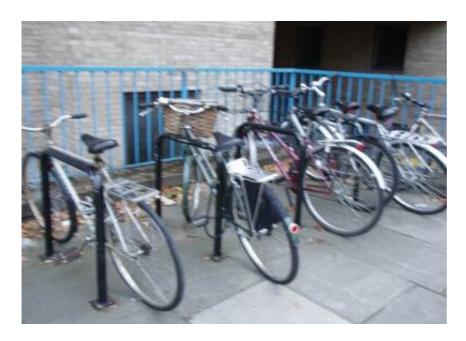
c) Lab block entrance. A few sheffield stands with 80cm spacing.

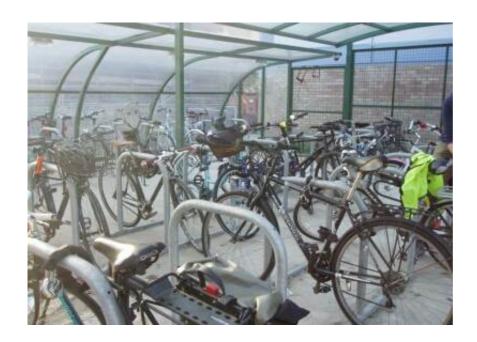
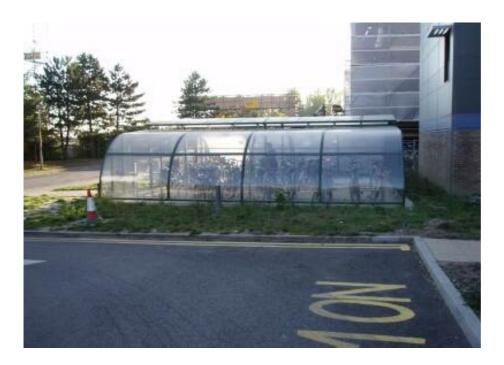
d) Rear of MRIS. Staff access shed, 80cm spacing toast racks.

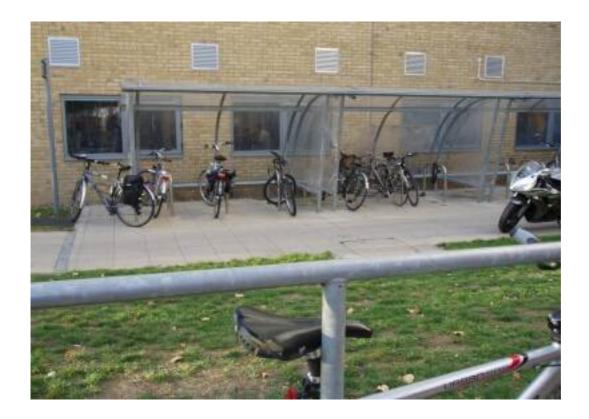
e) ATC staff entrance. 90cm spacing sheffield stands (covered).

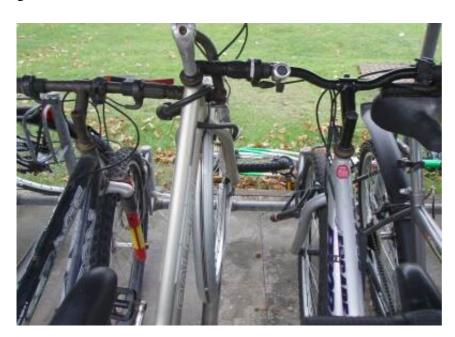
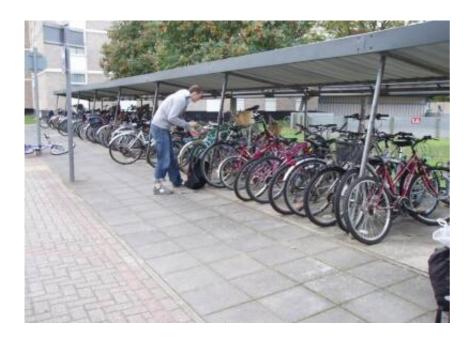
f) Residences. Covered wheel benders with totally inadequate spacing. Lack of spaces. Has there been an audit as to how many accessible spaces are provided for the number of occupants? Residents' only card access to proper shed to improve security? Clear lack of options for more spaces without sacrificing few grassed areas.

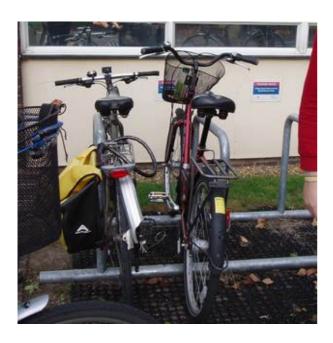
g) Toast rack outside Blood Transfusion. 61cm spacing. Marked "for blood donors only". How is this enforced?

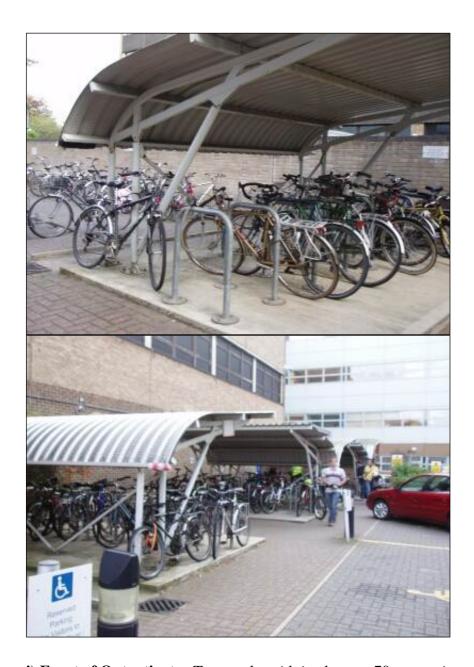
h) Rear of Hutchinson and CIMR. If design of sheds and spacing of racks was improved, could probably increase capacity by at least 20% and improve ease of use even with higher capacity. There are also parked cars blocking access to some of the spaces. We note that a planning application, subsequently withdrawn, was submitted for new cycle sheds in this area. Sadly the designs submitted appeared not to conform to the City Council standards, nor actually provide as many spaces as the application claimed they would.

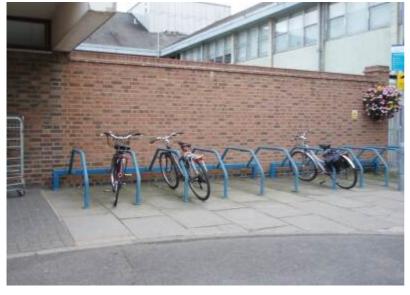
i) Front of Outpatients. Toast racks with inadequate 70cm spacing.

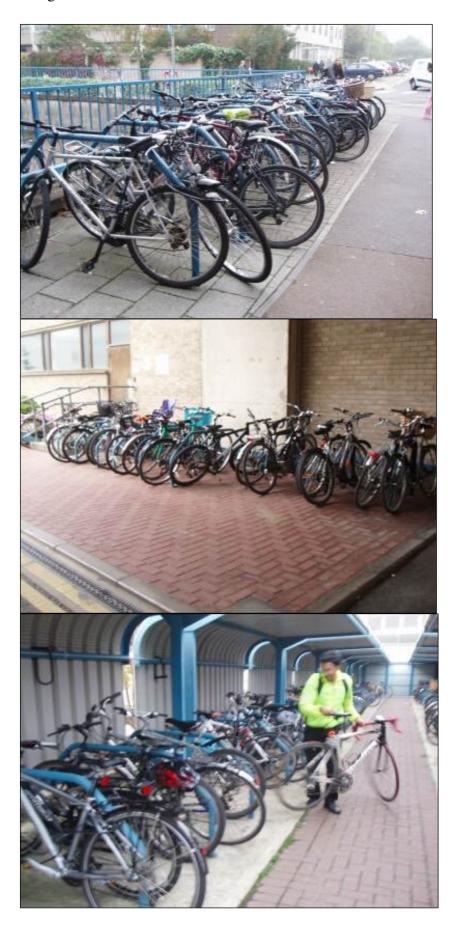
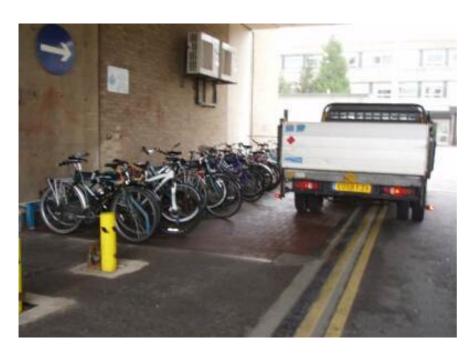
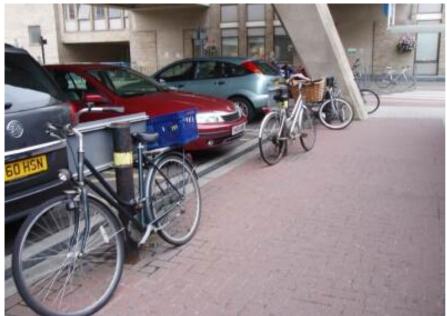
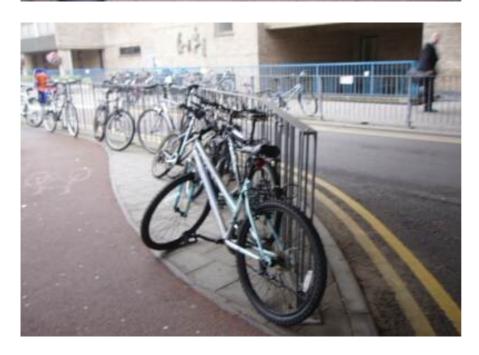
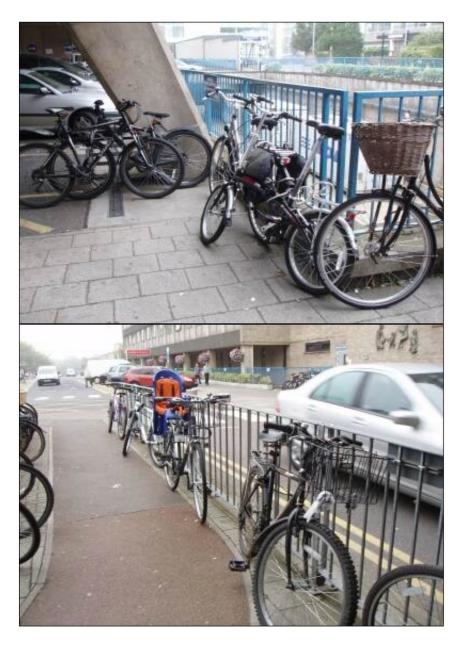
j) Outside Main Entrance. HC did separate survey at 8.30am on 27.9.11. Estimate that by that time, occupancy was >95% and many "vacant spaces" were in fact inaccessible as the bike parked alongside had

large basket or wide handlebars meaning it would have been difficult or impossible to get another bike in alongside.

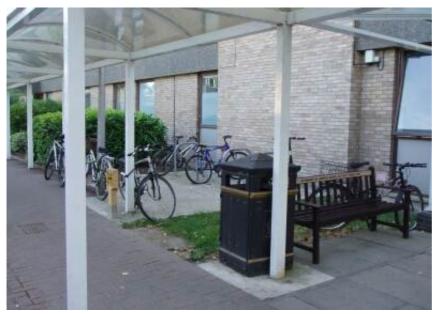
k) F, G, R and A block entrances. Very little space for many entrances. Note that good sheffield stands have been tucked in where ever possible. Only one spot identified where more might be put. Lots of parked cycles not parked on stands, suggesting that demand far outweighs supply.

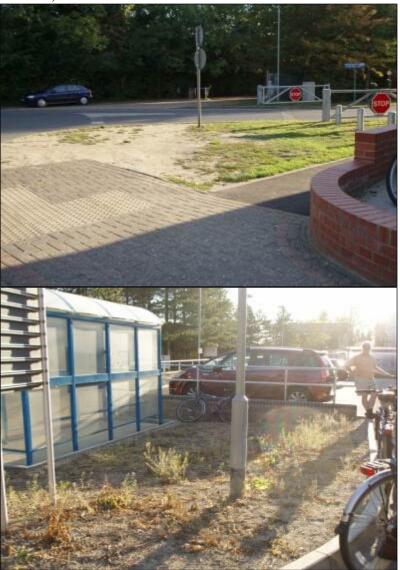
I) MRIS and N wards. There is space for more racks here. Space by current shed either needs to be made into a pleasant garden for use by staff and patients or it might as well be used for more cycle parking as it currently has no merit (uncovered toast racks with adequate spacing suggested as at least short-term solution).

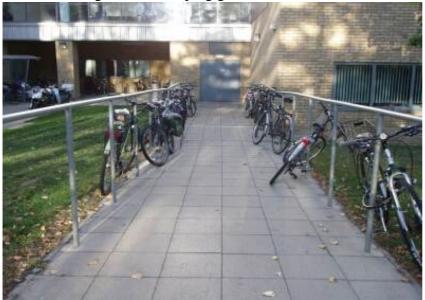
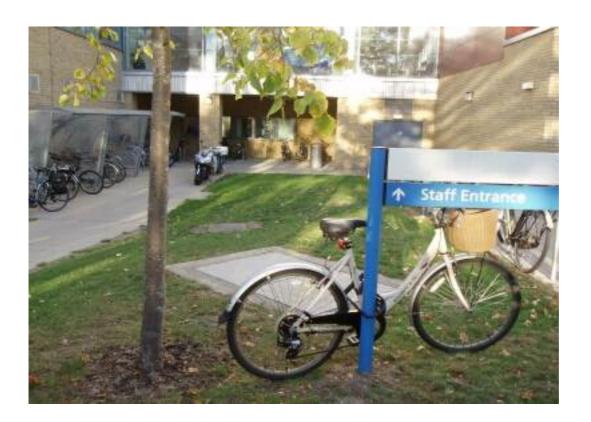
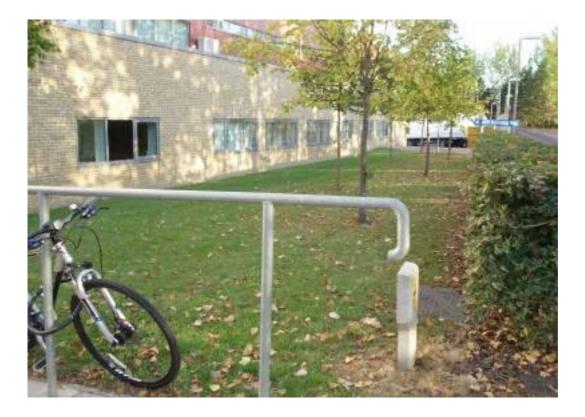
m) **ATC staff entrance.** Presence of lots of fly parked cycles near to rear of MRIS (d) suggests that demand far outstrips supply. Suggestion that grass area with trees outside windows should be made more attractive as a garden but sloping grass area nearer entrance sacrificed for more parking.

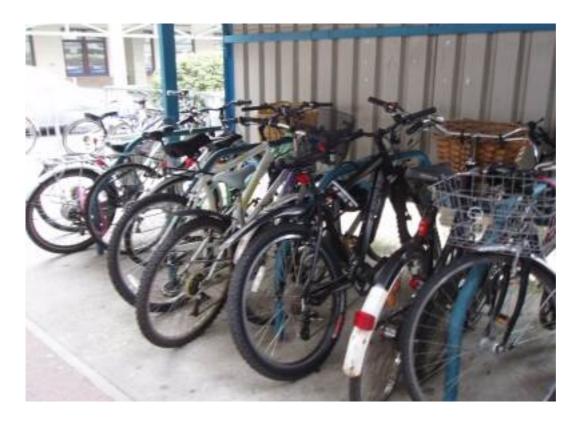
4.1) Could cycle parking be designated a sex and age discrimination issue for employees?

Spaces which may be useable by a man who is 6 feet tall and physically fit enough to be able to lift part of his cycle over a neighbouring cycle to get parked and still reach his frame to securely lock his cycle with no risk of injury may not be useable by a woman or older man who is 5 feet 4 inches tall with little upper body strength.

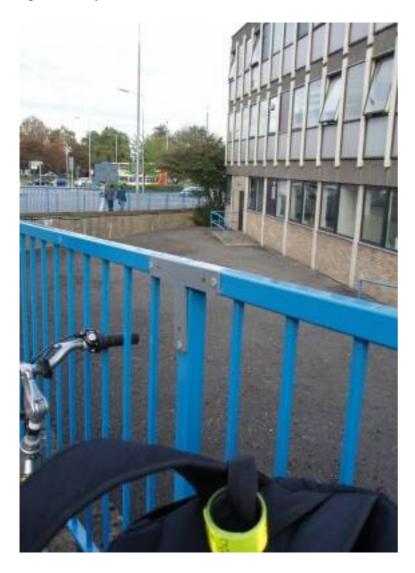
4.6) Corner by flagpole roundabout near Eye Unit.

Area at either basement or ground level depending on access. Access could be alongside Eye Unit door. Space totally unused and with no wildlife or other merit.
